# Asbestos Removal Response Action Minillas Complex North Tower San Juan, Puerto Rico

## Clearance Sampling Report

**UNITED STATES ENVIRONMENTAL PROTECTION AGENCY – REGION 2**

2013

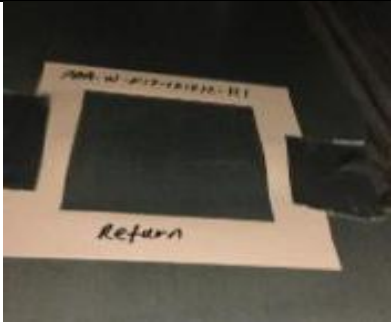
Sample Number	Results (s/cm <sup>2</sup> )	Picture	Sample Location	Component
PBA-W-17-121212-R1	< 1,000 (non detected)

A/C return (Common office to north)
PBA-W-17-121212-R2	< 1,000 (non detected)

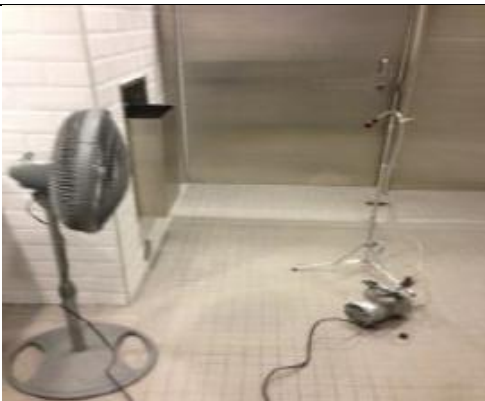
Random Area #4 (West machine room)
PBA-A-17-121212-5	0.0025 (NIOSH 7400) and <0.00042 (NOISH 7402)

Random Area #5 (Men restroom to center)
PBA-A-17-121212-6	<0.00075

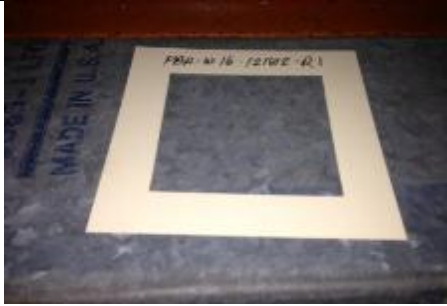
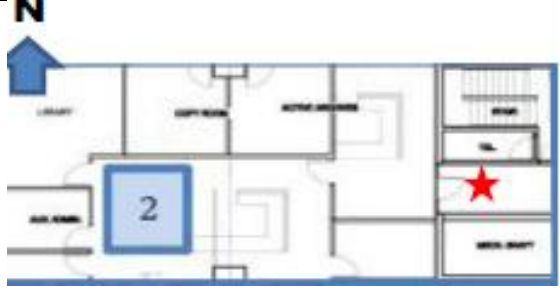
Sample Number	Results (s/cm <sup>2</sup> )	Picture	Sample Location	Component
PBA-W-16-121812-R1	< 1,000 (non detected)

A/C return (Lobby to west)
PBA-W-16-121812-R2	< 1,000 (non detected)

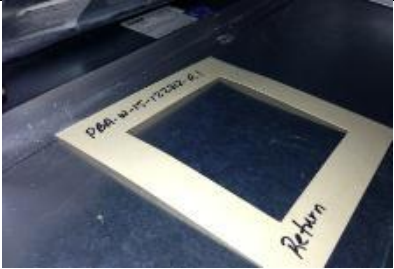
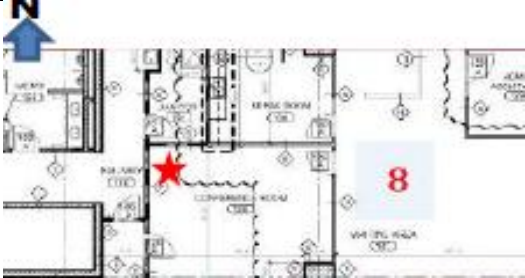
Sample Number	Results (s/cm <sup>2</sup> )	Picture	Sample Location	Component
PBA-W-15-122812-R1	< 1,000 (non detected)

A/C return (Conference room to east)
PBA-W-15-122812-R2	< 1,000 (non detected)

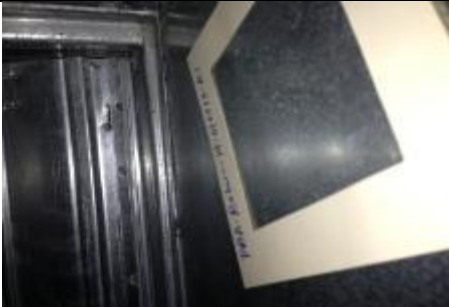
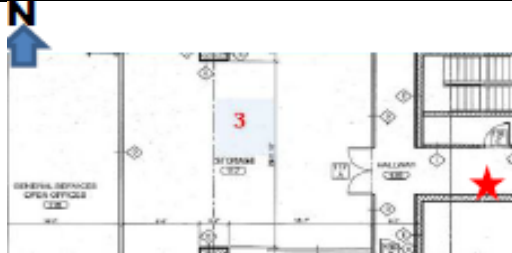
Sample Number	Results (s/cm <sup>2</sup> )	Picture	Sample Location	Component
PBA-W-14-010413-R1	2,100 (2 Chrysotile)

A/C return (Lobby to west)
PBA-W-14-010413-R2	< 1,000 (non detected)

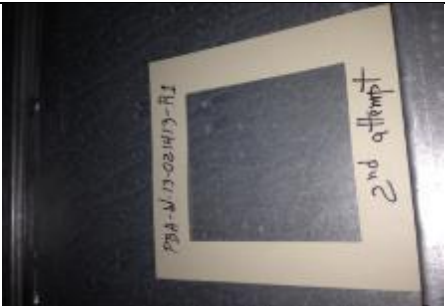
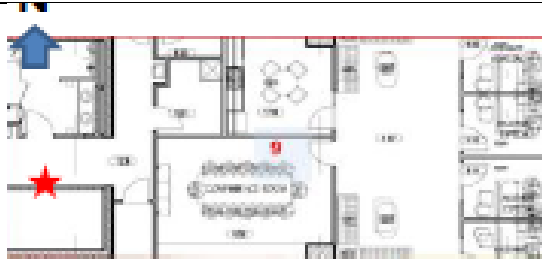
Sample Number	Results (s/cm <sup>2</sup> )	Picture	Sample Location	Component
PBA-W-13-021413-R1	< 990 (non detected)

A/C return (Lobby to east)
PBA-W-13-021413-R2	< 990 (non detected)

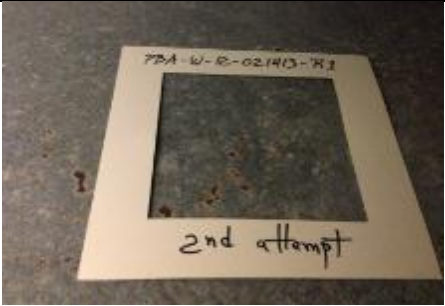
Sample Number	Results (s/cm <sup>2</sup> )	Picture	Sample Location	Component
PBA-W-12-021413-R1	< 990 (non detected)

A/C return (Lobby to east)
PBA-W-12-021413-R2	< 990 (non detected)

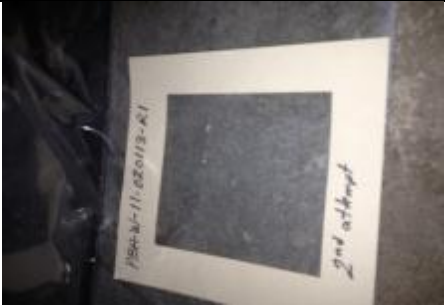
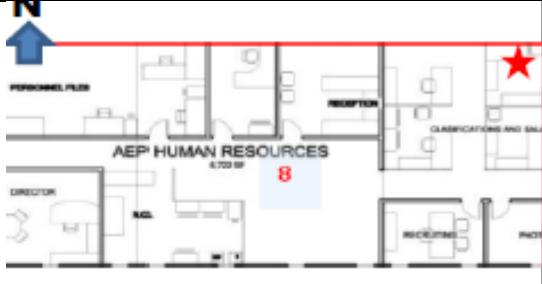
Sample Number	Results (s/cm <sup>2</sup> )	Picture	Sample Location	Component
PBA-W-11-020113-R1	<1,000 (non detected)

A/C return (Offices to east)
PBA-W-11-020113-R2	<1,000 (non detected)

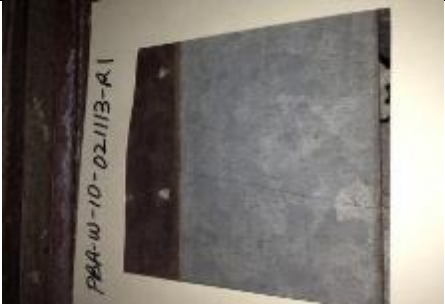
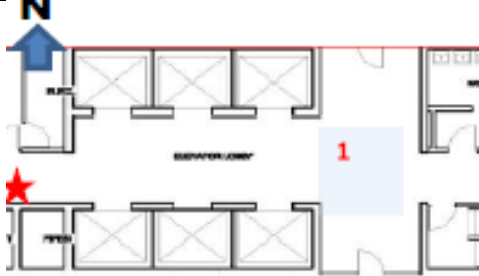
Sample Number	Results (s/cm <sup>2</sup> )	Picture	Sample Location	Component
PBA-W-10-021113-R1	<1,000 (non detected)

A/C return (Lobby to west)
PBA-W-10-021113-R2	<1,000 (non detected)

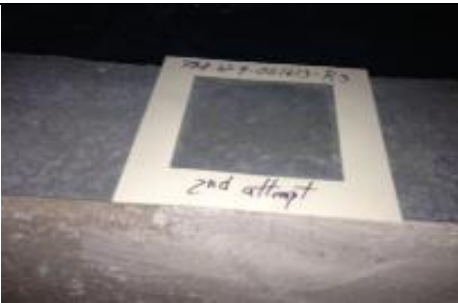
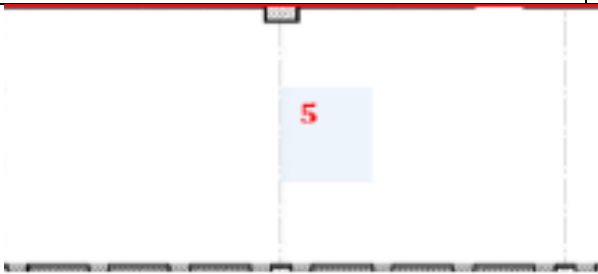
Sample Number	Results (s/cm <sup>2</sup> )	Picture	Sample Location	Component
PBA-W-9-021163-R1	<1,000 (non detected)	 	 	A/C return (Lobby to east)
PBA-W-9-021613-R2	<1,000 (non detected)	 	 	A/C return (Open space southeast)
PBA-W-9-021613-R3	<1,000 (non detected)

A/C return (Open space southwest)

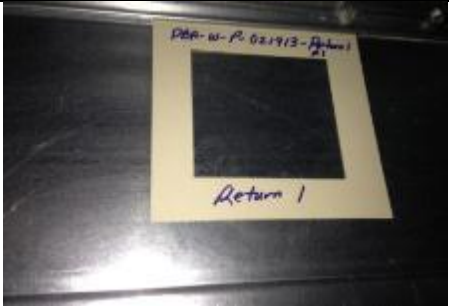
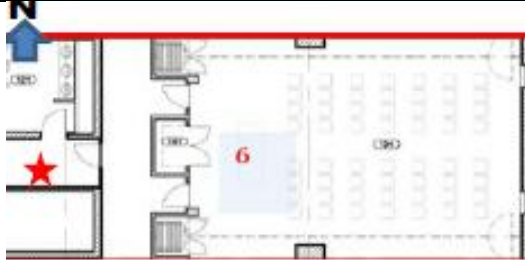
Sample Number	Results (s/cm <sup>2</sup> )	Picture	Sample Location	Component
PBA-W- P-021913-R1	<990 (non detected)

A/C return (Lobby to east)
PBA-W- P-021913-R2	<990 (non detected)

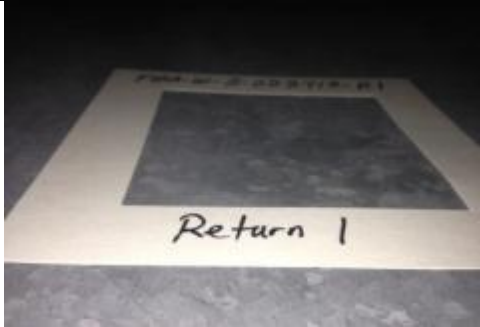
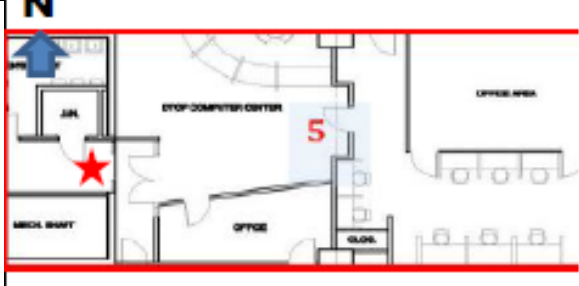
Sample Number	Results (s/cm <sup>2</sup> )	Picture	Sample Location	Component
PBA-W- 2-022713-R1	<990 (non detected)

A/C return (Lobby to east)
PBA-W- 2-022713-R2	<990 (non detected)

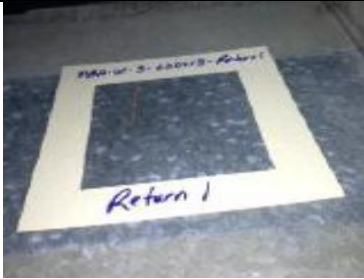
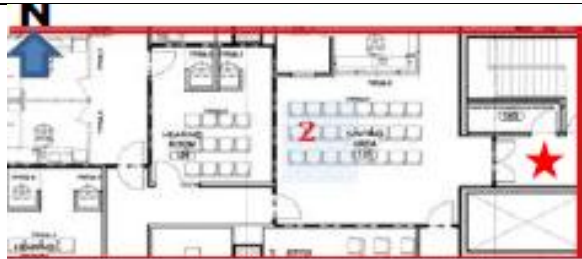
Sample Number	Results (s/cm <sup>2</sup> )	Picture	Sample Location	Component
PBA-W3-030213-R1	<990 (non detected)

A/C return (Lobby to west)
PBA-W- 3-030213-R2	<990 (non detected)

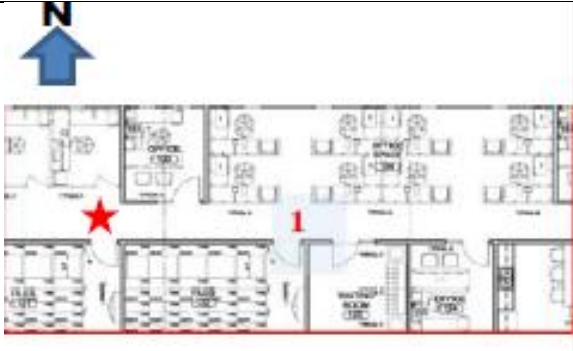
Sample Number	Results (f/cc)	Picture	Sample Location	Component
PBA-A- 3-030213-1	0.0084 by NIOSH 7400  <0.00076 by NIOSH 7402  (No asbestos fibers)

Random Area #1  (Open area to north)
PBA-A- 3-030213-2	0.0012

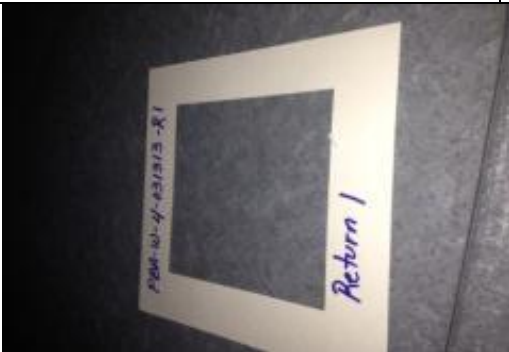
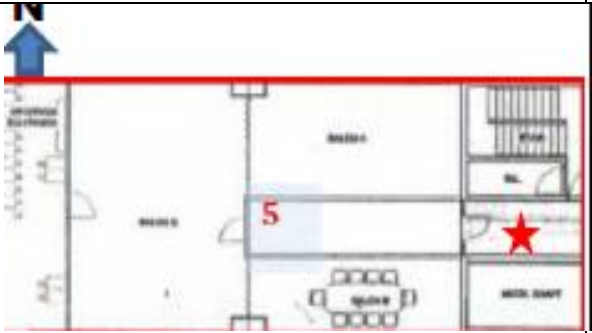
Sample Number	Results (s/cm <sup>2</sup> )	Picture	Sample Location	Component
PBA-W- 4-031313-R1	<990 (non detected)

A/C return (Lobby to west)
PBA-W- 4-031313-R2	<990 (non detected)

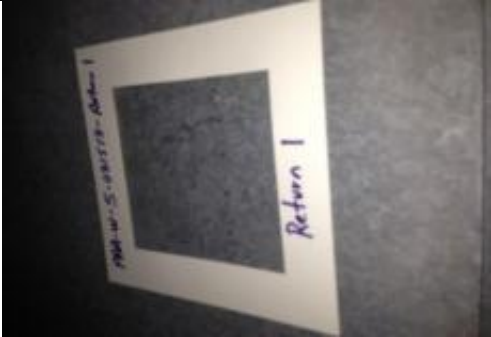
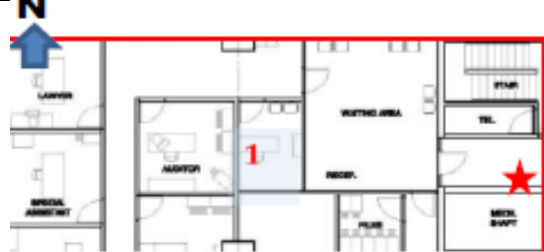
Sample Number	Results (s/cm <sup>2</sup> )	Picture	Sample Location	Component
PBA-W- 5-031513-R1	<990 (non detected)

A/C return (Lobby to west)
PBA-W- 5-031513-R2	<990 (non detected)

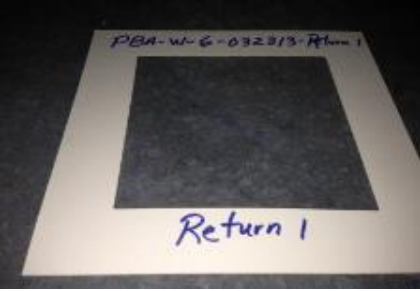
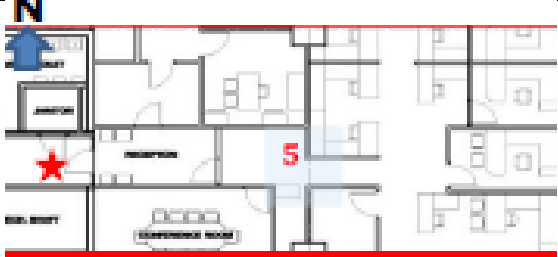
Sample Number	Results (s/cm <sup>2</sup> )	Picture	Sample Location	Component
PBA-W- 6-032313-R1	<990 (non detected)

A/C return (Lobby to east)
PBA-W- 6-032313-R2	<990 (non detected)

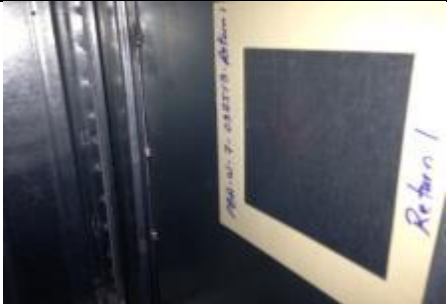
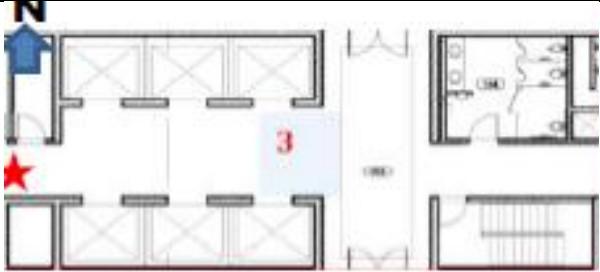
Sample Number	Results (s/cm <sup>2</sup> )	Picture	Sample Location	Component
PBA-W- 7-032513-R1	<990 (non detected)

A/C return (Lobby to west)
PBA-W- 7-032513-R2	990 (1 Chrysotile)

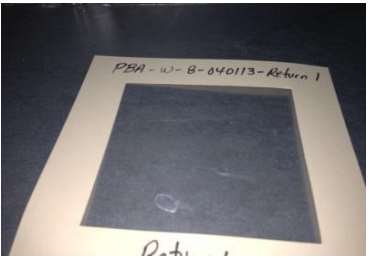
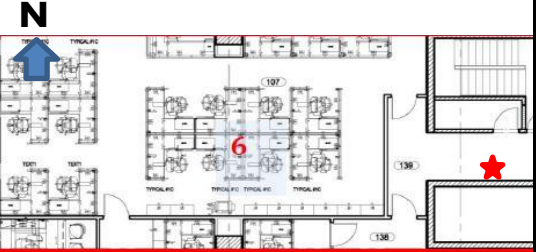
Random Area # 9 (Private office to SE) window frame
<b><u>Air Conditioning (A/C) Returns and Supply Wipe Dust Samples</u></b>					
Sample Number	Date	Result	Picture	RA Diagram (Approx. sample location)	Component
PBA-W-08-040113-R1	5-Apr-13	<990 S/CM2 (NONE DETECTED)

A/C return (Lobby to W)
PBA-W-08-040113-R2	5-Apr-13	<990 S/CM2 (NONE DETECTED)
